Diver Bay
'Hole in the Wall'
104-30-40
7-19-74
Downey

Name Diver Bay 'Hole in the Wall' Catalog No. 104-30-40
 Latitude 55° 10' 38" 40" WR No. _____
 Longitude 133° 11' 18" 13" K No. _____
 Geodetic Map No. Craig A-4 Work Area Ketchikan
 Location West Coast Dall Island Watershed Length 3/4 mile
 Drainage Area of Watershed _____
 Water Supply Type Springs, precipitation
 Trails & Survey Routes Walk in the stream.
 Aerial Survey Notes Could survey the I.T.Z. but is too small upstream
for surveying.
 Anchorage Refer to navigation chart #8151 and the Alaska Coast Pilot.
I think you could get a small boat in here.
 Tide Stage When Surveyed _____

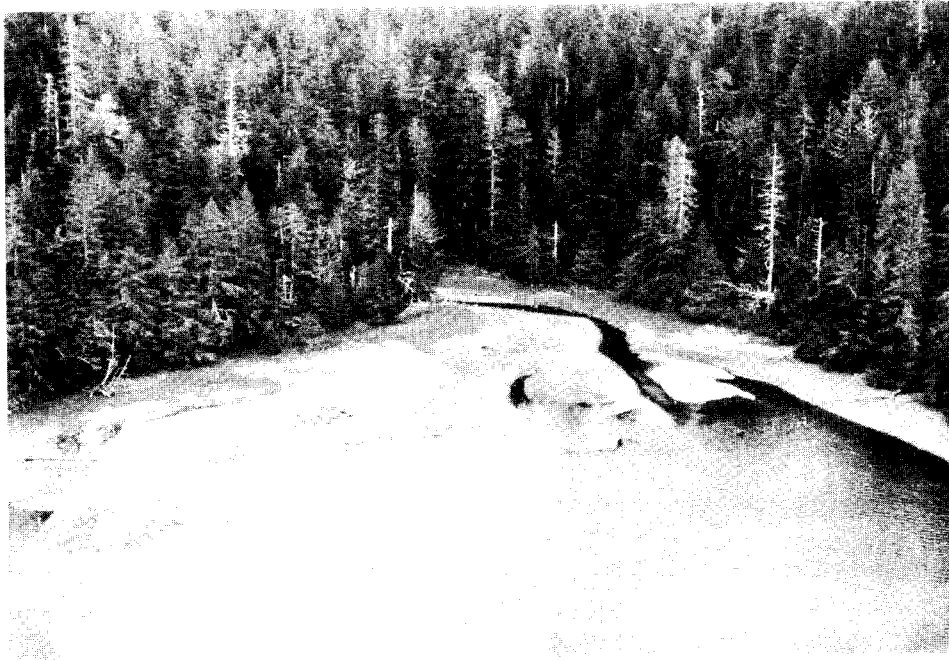
MOUTH OF 104-30-40 104-30-10400

This is the stream at the head of Hole in the Wall. Not a large stream by any means, but it does have some good gravel and could support spawners. Should be cataloged.
